Manhole Inspection Summary

Manhole # S23W__032MH

Insp Date: **2/10/09 1:39 PM**

Location Address: **2118 Ontario Ave.**

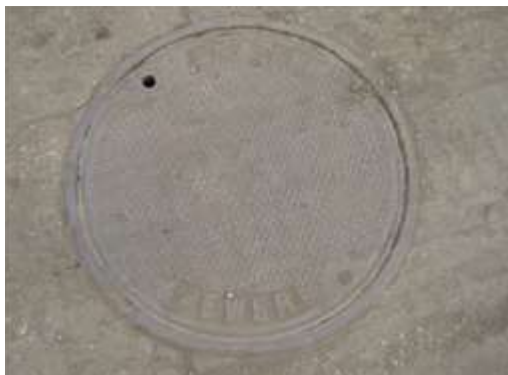
Misc

cover

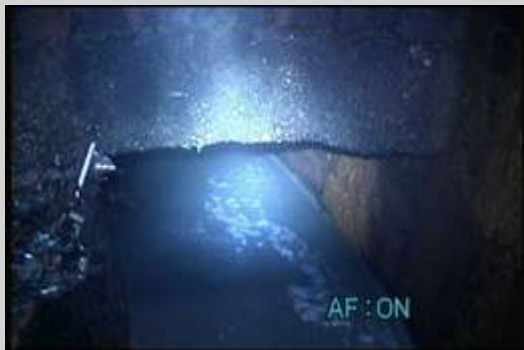
12 O'Clock Outflow

24 in. Circular Gravity Sewer
Pipe Out @ 12 O'Clock

Pipe Height: **24** (in.) Rod and Bar (Angled)
Pipe Material: **Clay** ☐ Pipe Lined
Invert Depth: **24.57** (ft.) Flow Characteristics: **Fast**
Deposits: ☒ None ☐ Mud ☐ Sludge ☐ Debris ☐ Grease
Silt Depth: **0** (in.) Deposits Extent:
Infiltration: **None** Pipe Seal Cond: **Sound**

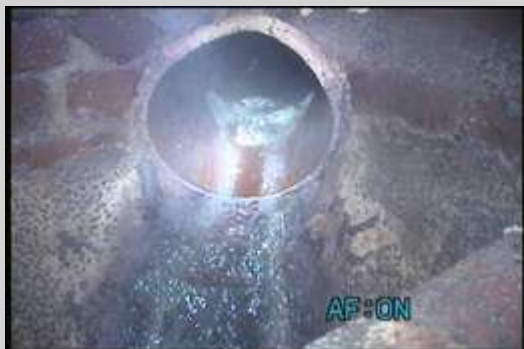
3 O'Clock Inflow

8 in. Circular Gravity Sewer
Pipe In @ 3 O'Clock

Pipe Height: **8.4** (in.) Rod and Bar (Angled)
Pipe Material: **Clay** ☐ Pipe Lined
Invert Depth: **9.05** (ft.) Flow Characteristics: **None**
Deposits: ☒ None ☐ Mud ☐ Sludge ☐ Debris ☐ Grease
Silt Depth: **0** (in.) Deposits Extent:
Infiltration: **None** Pipe Seal Cond: **Sound**

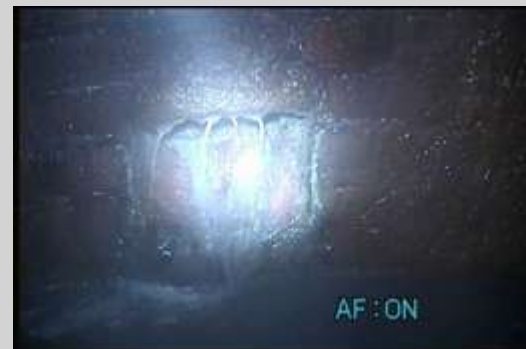
Drop In @ 3 O'Clock

Drop: **Inside** Rod and Bar
Angled: **Yes** Reading: **22.50** (ft.)
Inv Depth: **23.50** (ft.)
Drop Condition: **Open**

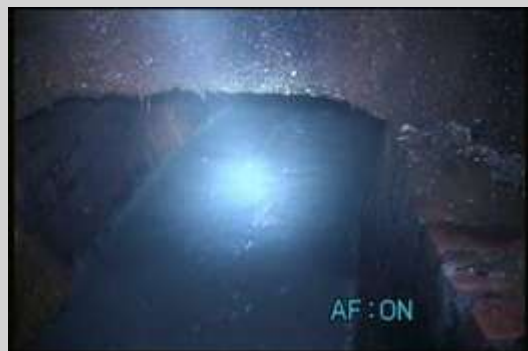
6 O'Clock Inflow

24 in. Circular Gravity Sewer
Pipe In @ 6 O'Clock

Pipe Height: **24** (in.) Rod and Bar (Angled)

Infiltration: **None** Pipe Seal Cond: **Sound**
